# Davis-Besse Reactor Vessel Head Damage NRC UPDATE

February 2003

This is the sixth periodic update on the NRC response to the reactor vessel head damage at the Davis-Besse Nuclear Power Station. The updates will be available at public meetings of the NRC Davis-Besse Oversight Panel which is coordinating the agency's activities related to the damage. Each update will include background information to assist the reader in understanding issues associated with the corrosion damage.

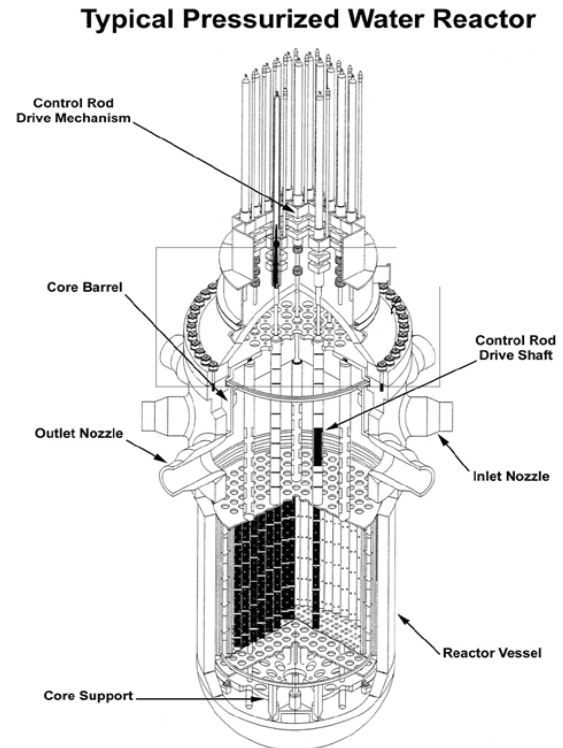
Corrosion, caused by the boric acid, damaged the vessel head next to Nozzle No. 3, creating an irregular cavity about 4 inches by 5 inches and approximately 6 inches deep. The cavity penetrated the carbon steel portion of the vessel head, leaving only the stainless steel lining. The liner thickness varies somewhat with a minimum design thickness of 1/8 inch. Subsequent examination by Framatome, FirstEnergy's contractor, found evidence of a series of cracks in the liner, none of which was entirely through the liner wall.
